**Environmental Condition Report  
For  
Rockville Agreed Area Site**

Naval Air Station Keflavik, Iceland  
Public Works Department

**ENVIRONMENTAL CLOSURE PLAN  
H-1 RADAR SITE (ROCKVILLE)  
KEFLAVIK NAVAL AIR STATION, KEFLAVIK, ICELAND**

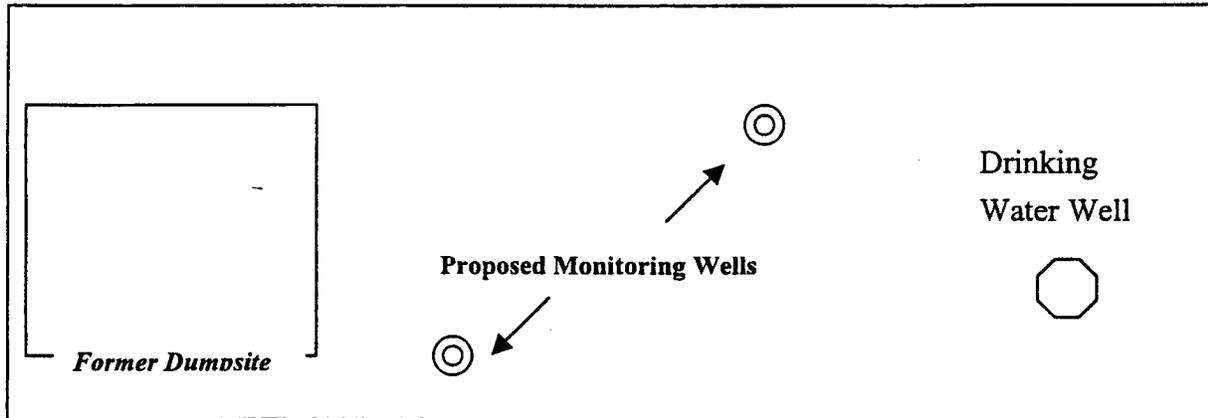
To determine if contaminants have migrated from the former dump either into the adjacent soil layers or into the ground water and to determine the direction of the groundwater flow, the following protocol is recommended.

Two monitoring wells would be installed at a depth of approximately 20 feet (6.1 meters) as shown in the above figure. Exact locations would be field verified and determined. The drinking water well will serve as the third well for triangulation. Water elevation and recharge rates measurements would be made on the site, and this would then be used to determine the direction of the groundwater flow. Each of the two new wells would require sampling for soil at the capillary fringe, and one water sample would be collected from all three wells. Soil and water samples will be analyzed for Target Analyte List (TAL) metals, and Target Compound List (TCL) volatiles, semi-volatiles, and pesticides/PCBs.

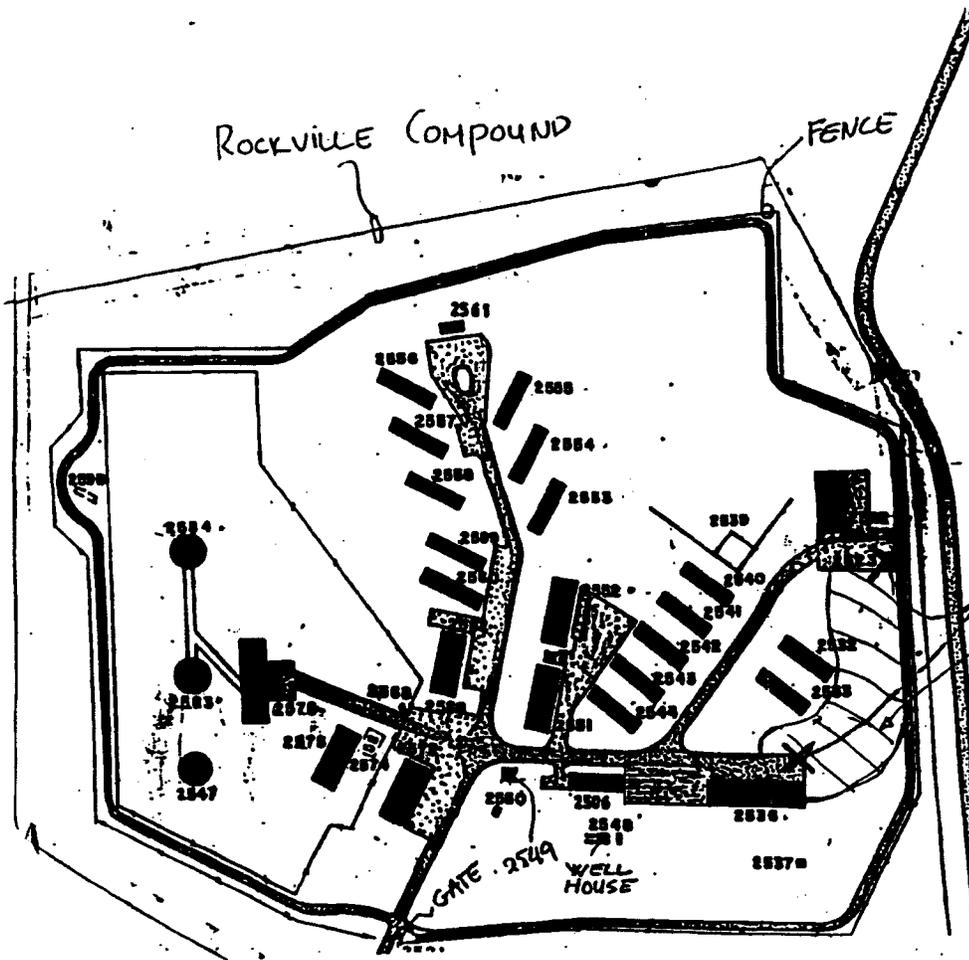
APPROXIMATE LOCATION OF MONITORING WELLS

Further investigation into the exact location of the former dump through interviews with Air Force personnel and site visits by the Environmental Division staff indicated that the former dump was actually located northeast of the location marked in the environmental closure plan as marked in the figure contained in Appendix 1. The Environmental Division noted that there was no evidence of surface contamination during several different site visits and the former dump site is now covered with rocks and vegetation which is consistent with the description provided in the environmental closure plan.
