**ENVIRONMENTAL CONDITION REPORT
FOR
HVALFJORDUR (WHALE BAY) FUEL FACILITY**

Naval Air Station Keflavik, Iceland
Public Works Department
Environmental Division

September 2002

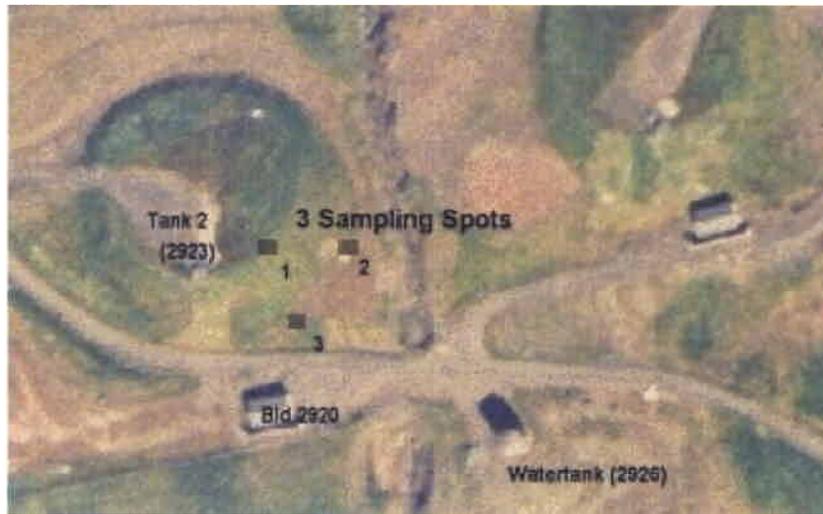
Figure 2.1 Sampling Sites

1. In 1975, according to IPC personnel, approximately 1,000–4,000 gal of oil leaked from a crack near the bottom of Tank No. 2. The spill impacted the facility drainage system in place at the time. No remaining evidence of this spill was observed at the time of the site visit on April 4, 2002. Three samples were taken below tank 2 (Figure 2.1) and analyzed (Appendix B.) No traces of oil products were found in any of the three samples.
