## Naval Facilities Engineering Command

# Abstract of an Accident

01-03

**Type of Work:** Removing Concrete Support Forms from beneath Pier.

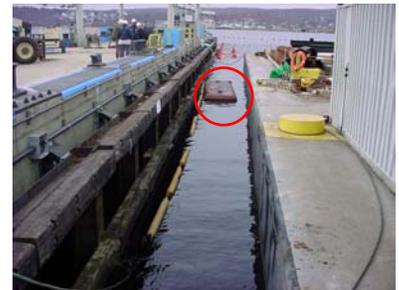
Outer float at accident site.

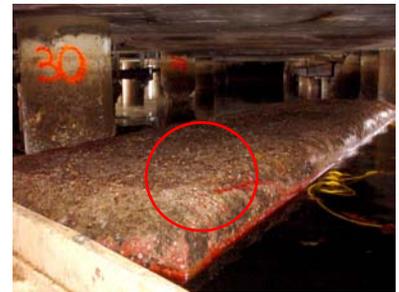
- ◆ Instability of material float.
- ◆ Employee walking on loaded unstable material float.

- ◆ Loading of steel beams off center on material float.
- ◆ Lack of job/site specific Activity Hazard Analysis (AHA).
- ◆ Lack of stability calculations for material float.
- ◆ Failure to follow work practices or procedures for loading steel beams on material barge.

Inner capsized material float.

- ◆ AHA must be site specific for each definable feature of work.
- ◆ AHA must address all control measures to be followed.
- ◆ Employees must follow set work procedures identified.

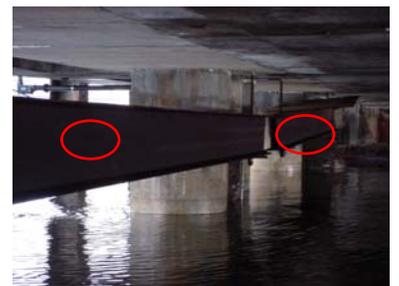
Concrete support steel beams ready for retrieval.

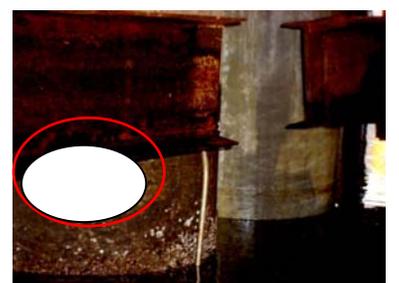
Close up of steel beams

with lifting washer and nut.
