Atlantic Division, Naval Facilities Engineering Command
ACCIDENT ABSTRACT

ACCIDENT TYPE: Crane over turned
INJURY: No Injuries
TYPE OF WORK: Demolition of underground tank
EQUIPMENT INVOLVED: Crawler, Fix boom
SAFETY EQUIPMENT: Long pants, shirt, safety glasses, and hardhat

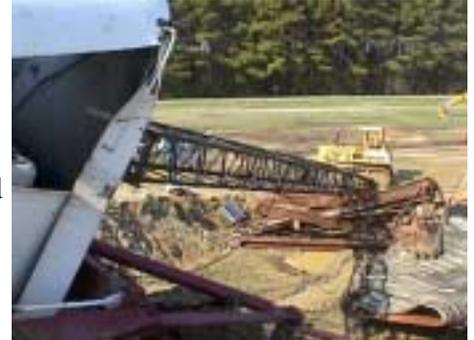
A contractor crane was removing and relocating scrap metal materials off of an underground tank during demolition.

The crane was overloaded for the configuration at the time of the accident.

- ◆ The crane was on unstable ground. The soil was disturbed.
- ◆ The crane had no load indicating device. .
- ◆ The operator did not know he was over loaded.
- ◆ Improper clamshell for removing scrap metal material.
- ◆ The operator did not have a current operator certification on site.
- ◆ The demolition plan was used to remove all tanks under the contract. It was not written as site specific. The plan calls for the use of a headache ball / crane rigging on a crawler. The contractor was using a clamshell. This was not specified in the demolition plan.
- ◆ The Activity Hazard Analysis was not amended or reviewed when the equipment used changed.
- ◆ The Preparatory Inspection was not amended, or reviewed with the crane operator.

All lattice boom cranes shall be equipped with a load indicating device or a load moment indictor, EM 385-17.D.01.
