**Hole drilled for
POL pipe hanger
support through
pier deck.**

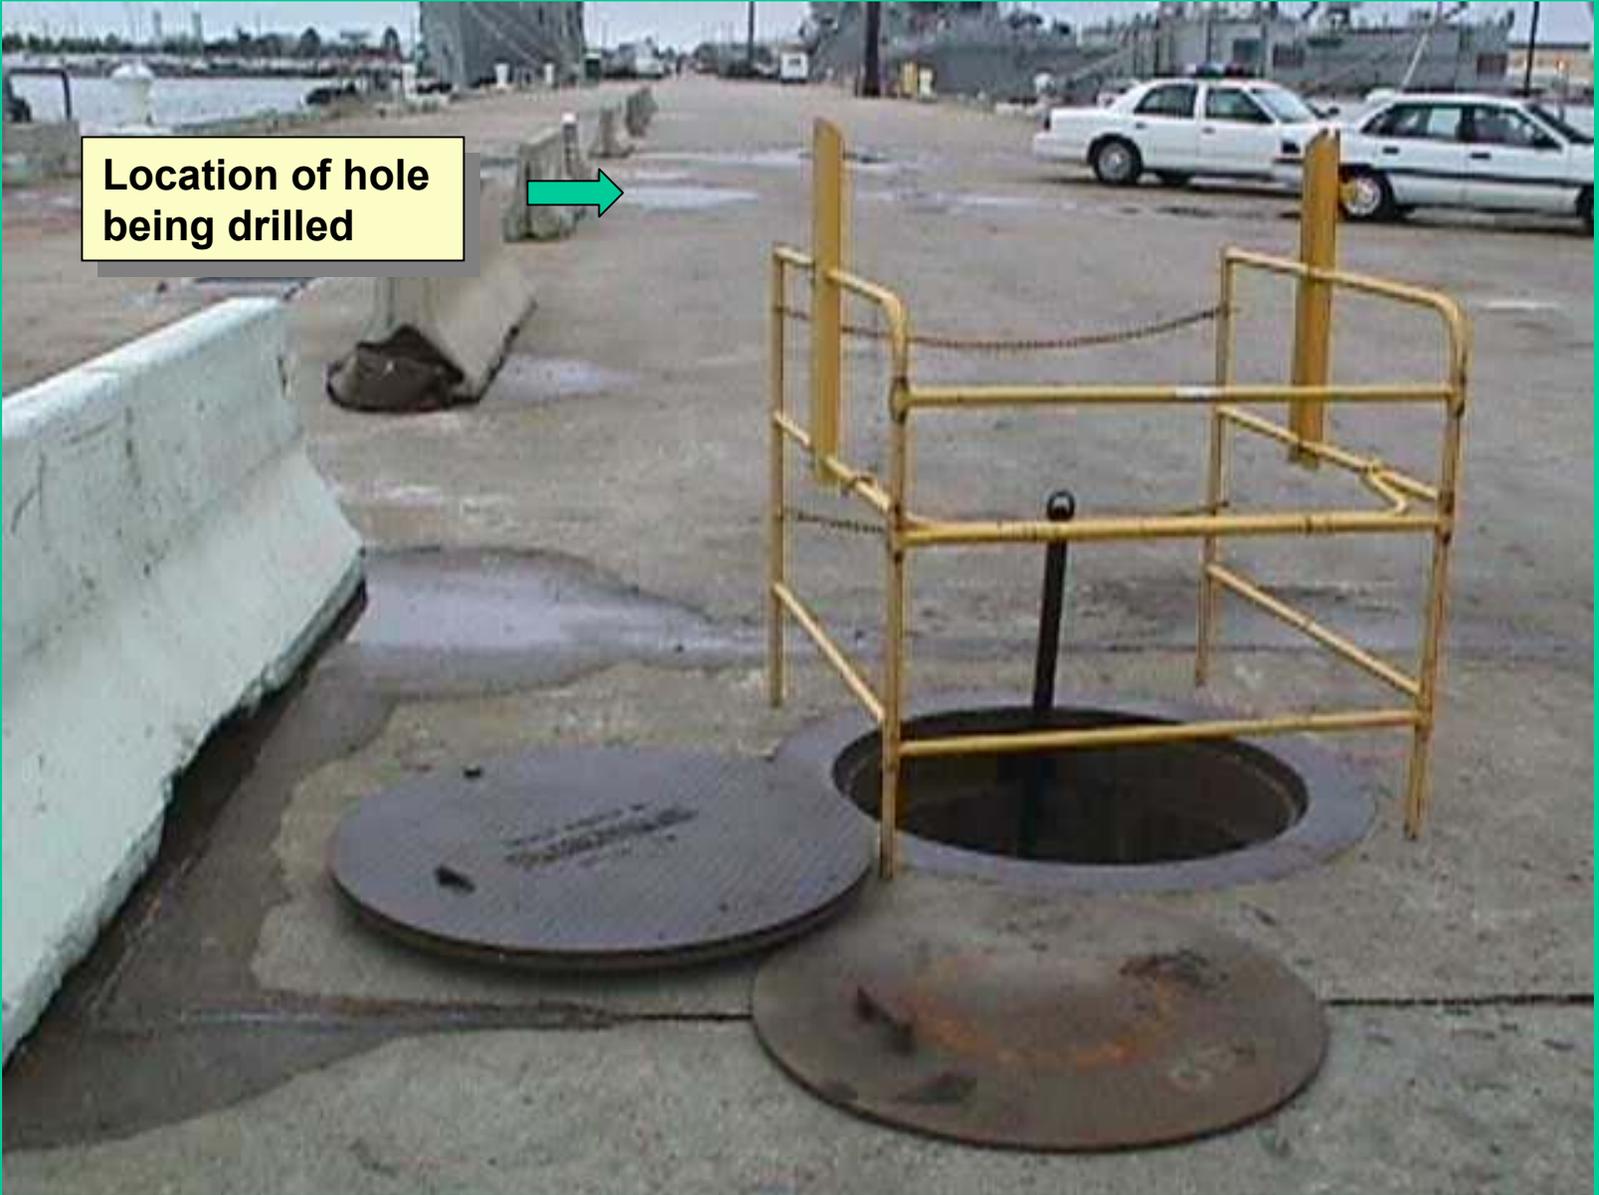
**Location of hole
being drilled**

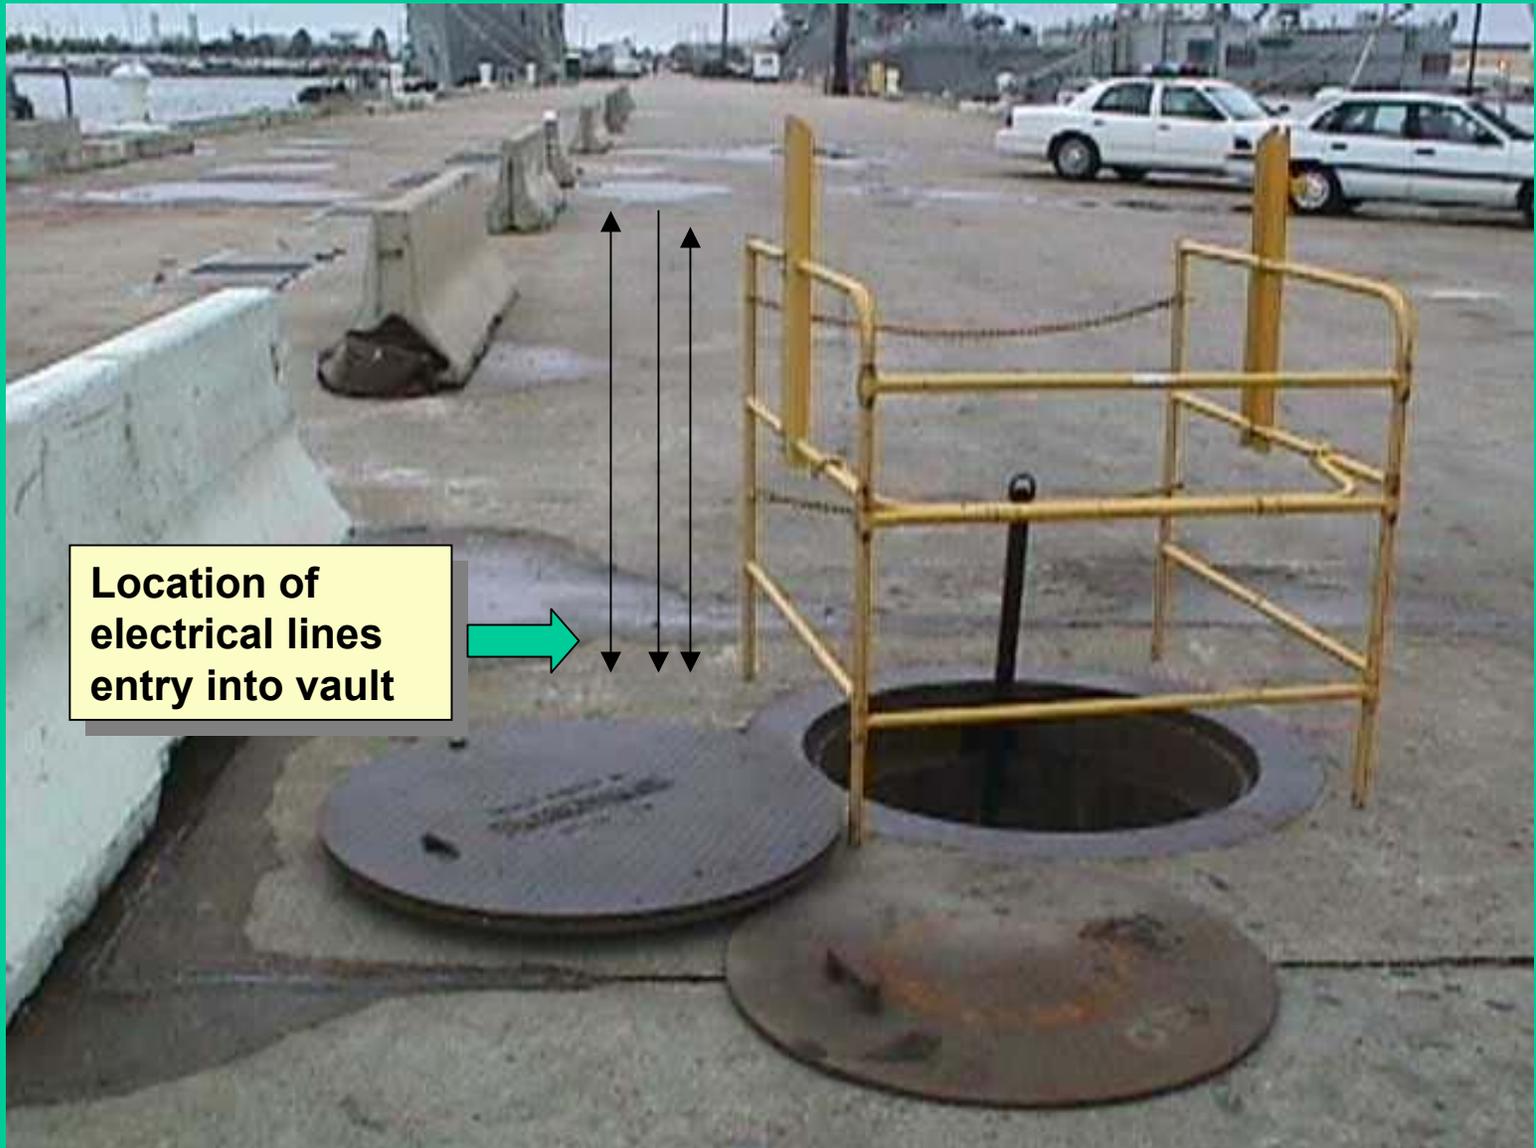
**Location of
electrical lines
entry into vault**

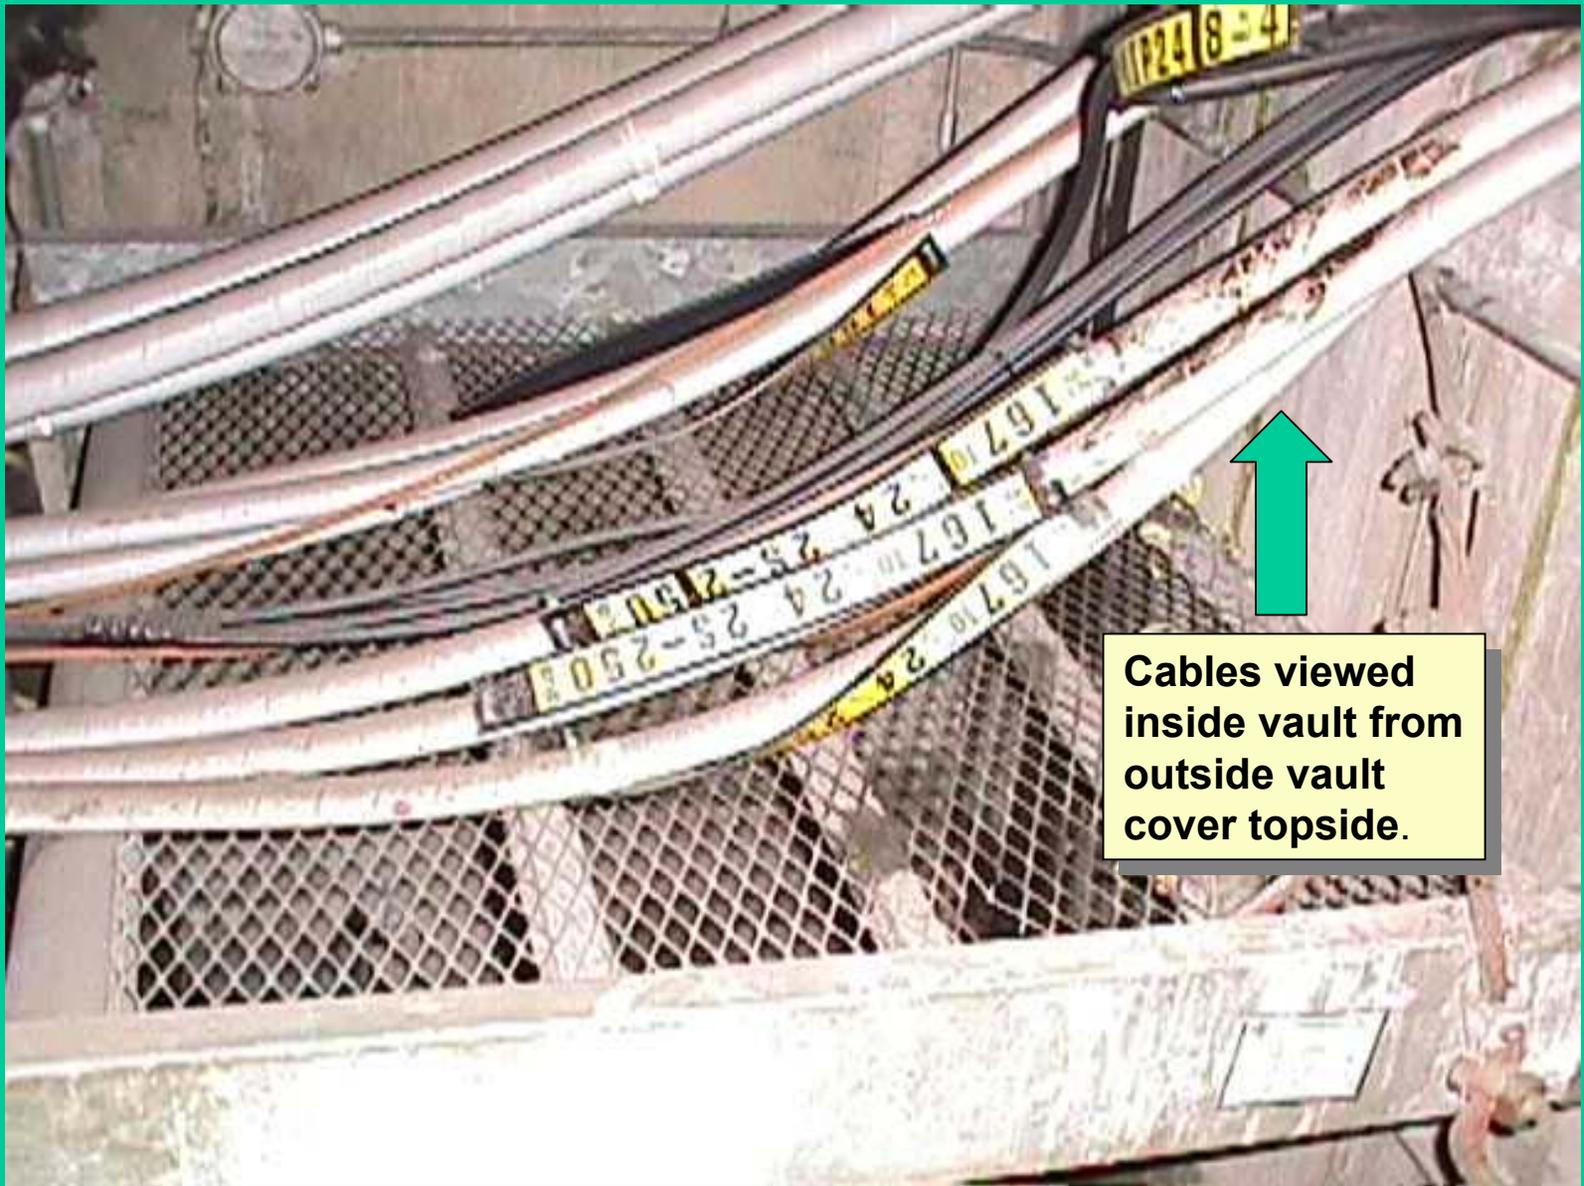
**Cables viewed
inside vault from
outside vault
cover topside.**

**Drill bit burnt
from High
Voltage contact**
