Naval Facilities Engineering Command

# Abstract of an Accident

03-01

**Accident Type:** Struck By/Crushing  
**Injury:** Fatality  
**Type of Work:** Removing Concrete Support Forms From Beneath Pier  
**Equipment:** Material Float, Come-a-long and Dinghy

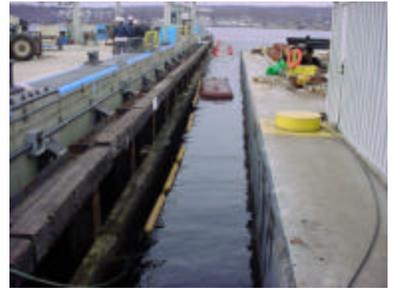
Outer float at accident site.

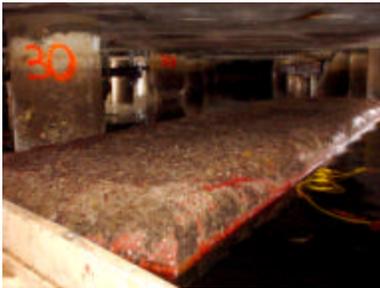
Inner capsized material float.

- ◆ Instability of material float.
- ◆ Employee walking on loaded unstable material float.

- ◆ Loading of steel beams off center on material float.
- ◆ Lack of job/site specific Activity Hazard Analysis (AHA).
- ◆ Lack of stability calculations for material float.
- ◆ Failure to follow work practices or procedures for loading steel beams on material barge.

- ◆ AHA must be site specific for each definable feature of work.
- ◆ AHA must address all control measures to be followed.
- ◆ Employees must follow set work procedures identified.

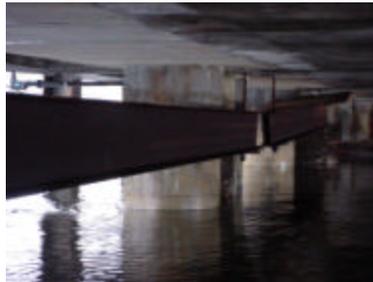
Concrete support steel beams ready for retrieval.

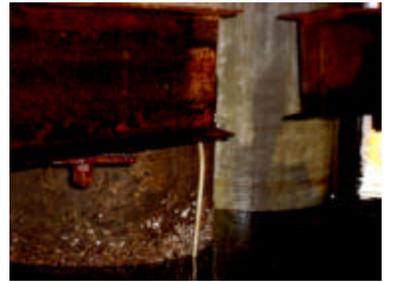
Close up of steel beams with lifting washer and nut.
