Atlantic Division, Naval Facilities Engineering Command

Abstract of an Accident

Accident Type: Fall
Injury: Broken arm/laceration
Type of work: Reinforcing Steel

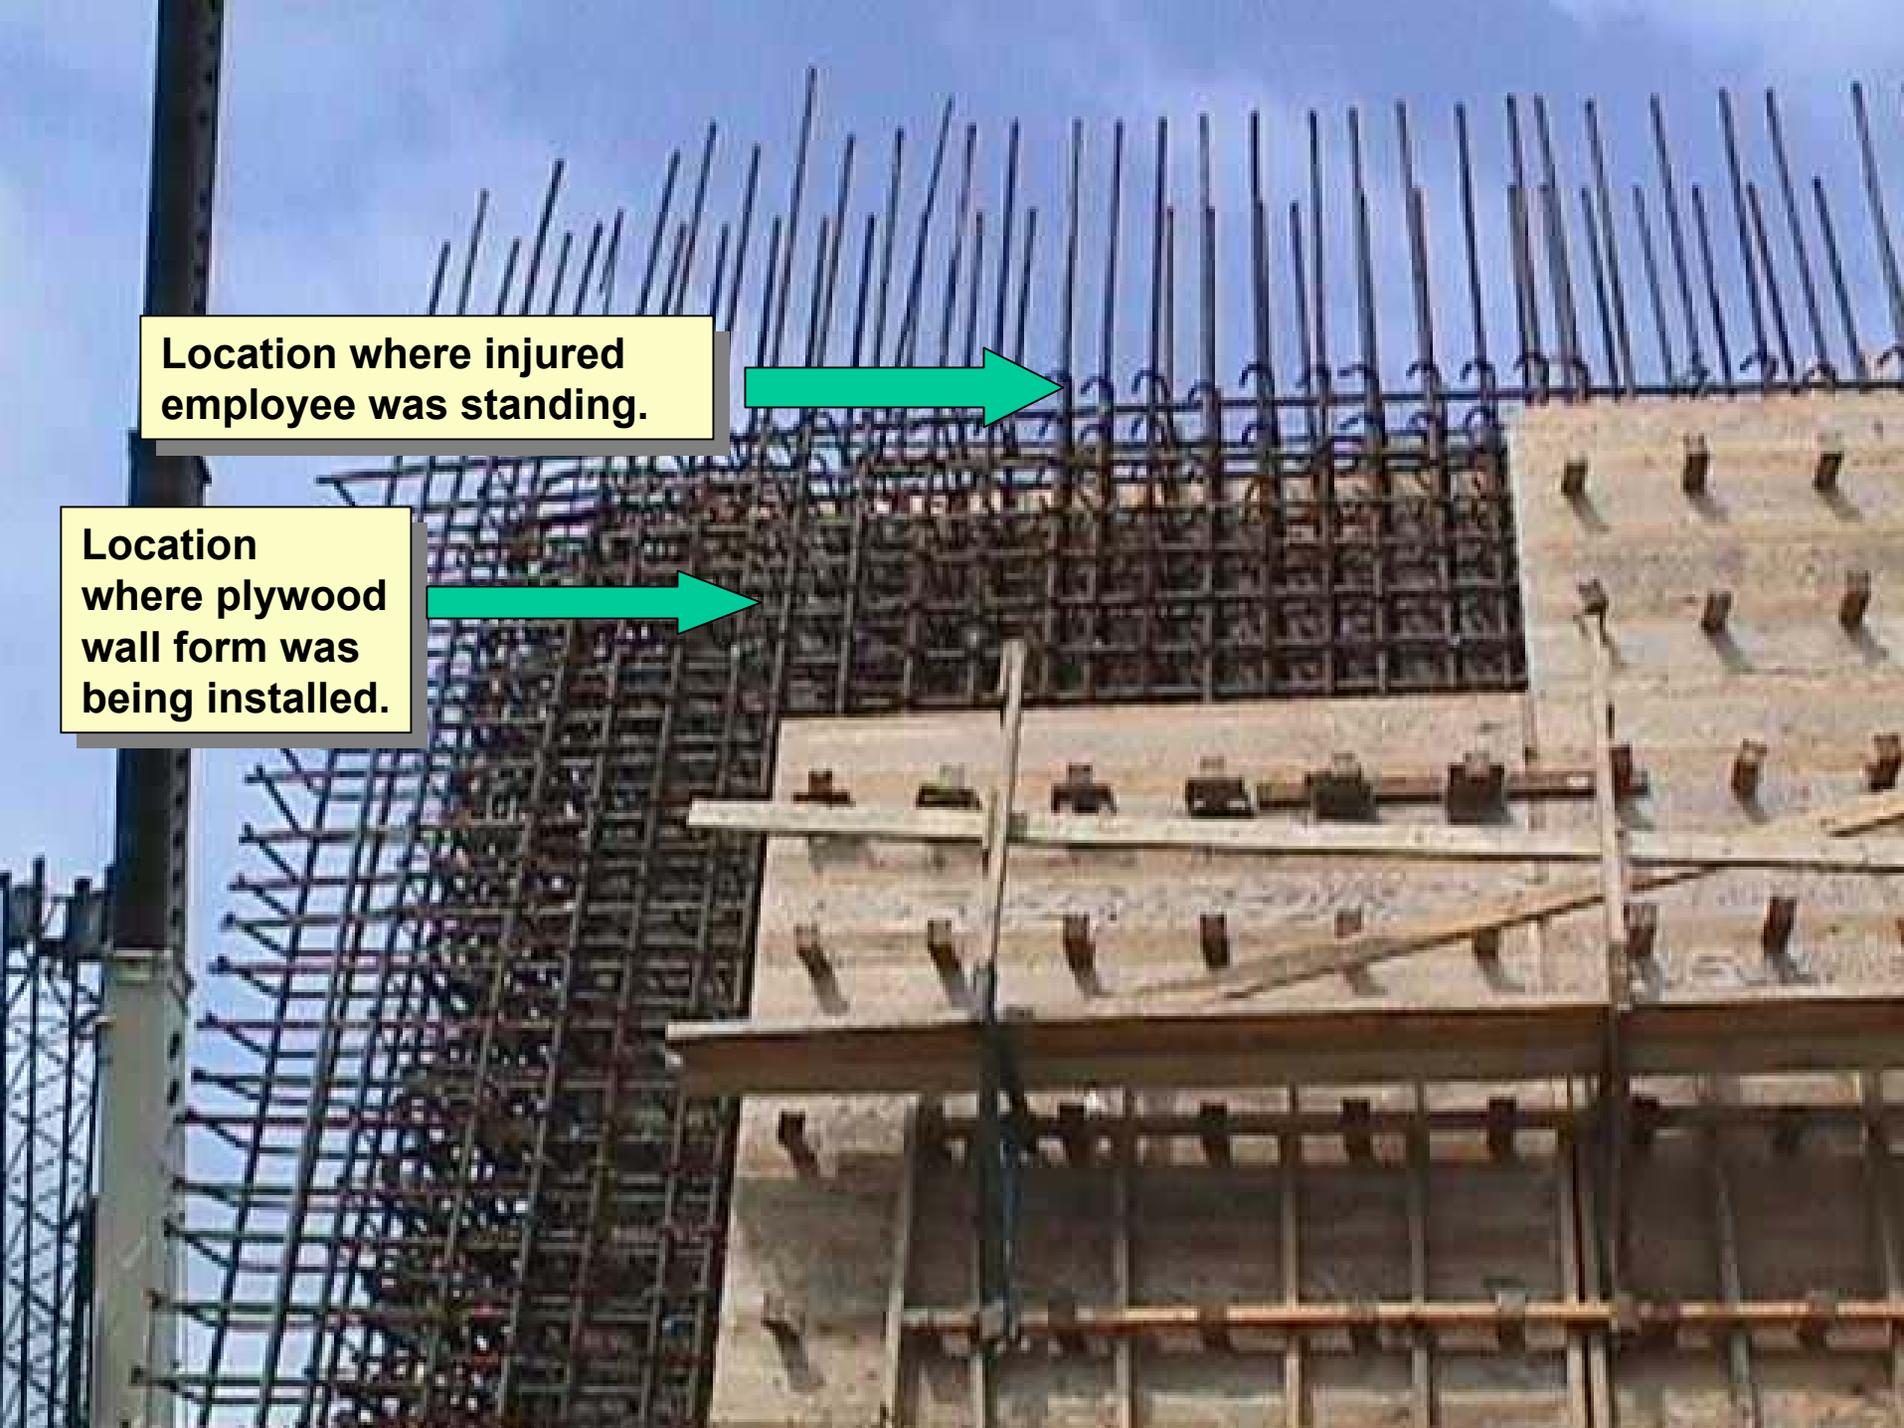
Location where injured employee was standing.

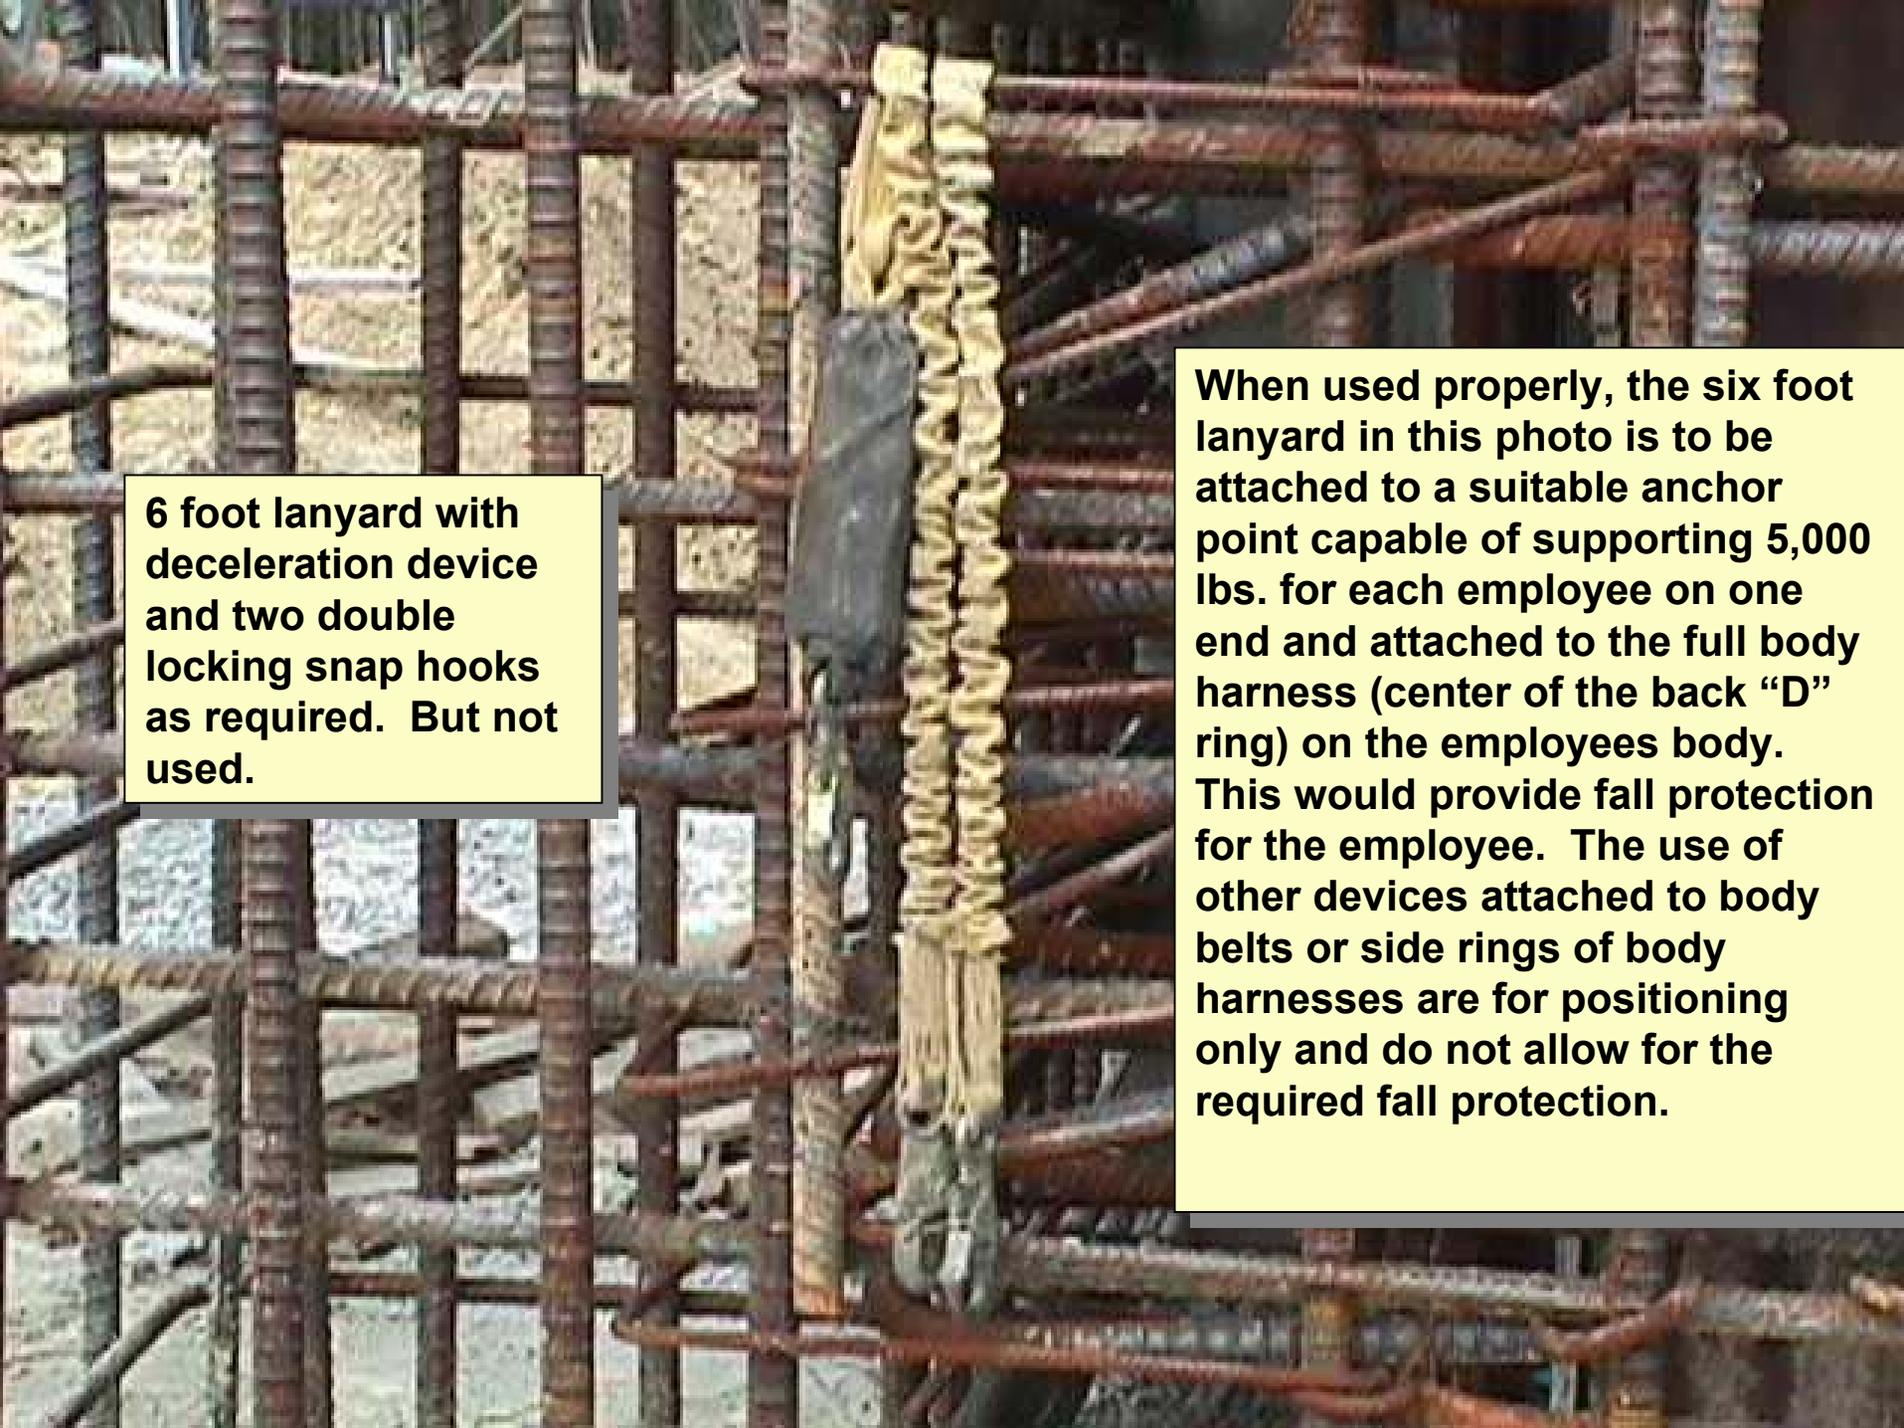
Improper tie off point by employee to “DOG” (#6 rebar) secured with tie wire. “DOG” dislodged, flipping downward, causing an open hook situation allowing the positioning device to slide off.
