**ENVIRONMENTAL CONDITION REPORT
FOR
HVALFJORDUR (WHALE BAY) FUEL FACILITY**

Naval Air Station Keflavik, Iceland
Public Works Department
Environmental Division

September 2002

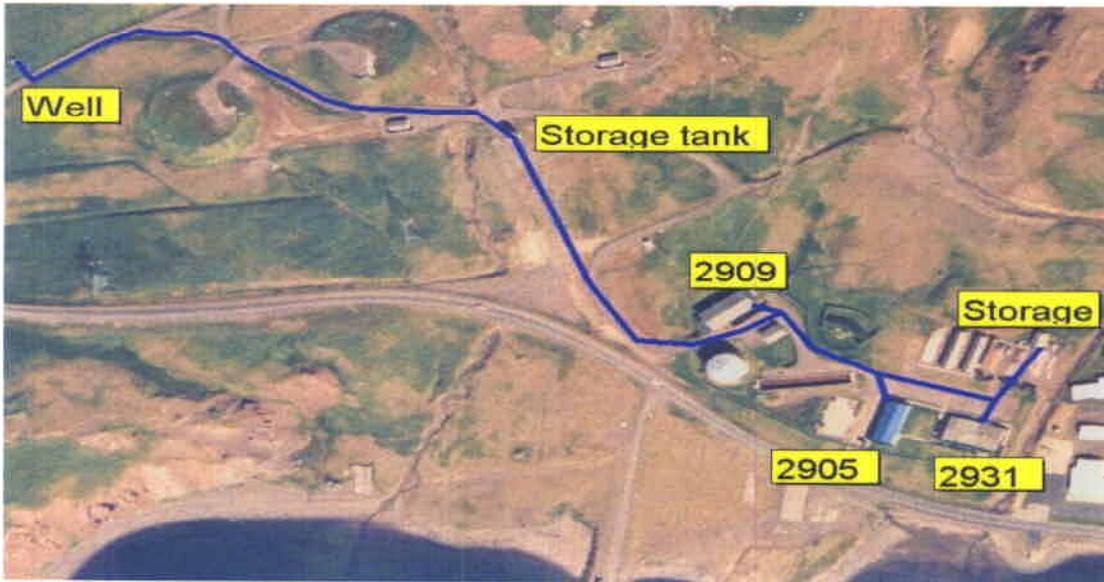
Figure 2.2 Estimated distribution system layout

The installation receives potable water from a single well, located just outside the installation fence. An additional well is located within the installation fence, which is inactive and the well casing has collapsed. It is unclear where individual mains in the system are located as no drawings could be found. Figure 2.2 is provided as an estimation of where the water mains are located based on the buildings and interviews with long-term employees. Building #2909 houses a boiler and serves as a power plant, building #2905 houses a mechanical shop and fire department, and building #2931 houses a kitchen and employee facilities. The drinking water at this facility does not undergo chemical treatment; water flows directly to a storage tank, located on the hillside above the buildings in use.

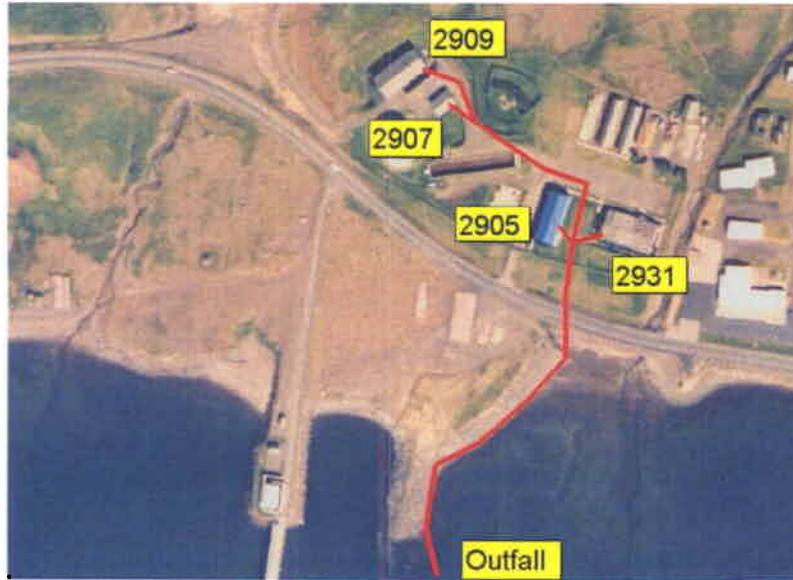
Figure 2-3 Estimated sewer layout

Sewage from the majority of the facility is discharged via an outfall into Whale Bay adjacent to the pier. Sewage from the powerhouse and office buildings is discharged into a tidal field located north of Bldg. 2906. No evidence of contamination at the sewer outfall or tidal field has been reported or observed. This type of rudimentary sewer system is standard for Iceland.

Drainage water from under the fuel tanks travels to an oil-water separator. This separator is also equipped with a device capable of identifying fuel in the drainage water and subsequently sounding an alarm. The effluent of the oil-water separator is connected to the sewer system near building #2905.
